State of Utah
DEPARTMENT OF NATURAL RESOURCES
DIVISION OF OIL, GAS AND MINING

January 22, 2003

Site Inspection, Neil Bradshaw, Bright # 1 and 2, S/021/030, Iron County, Utah

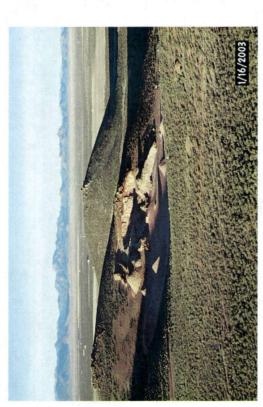
The areas being mined are low hills where there are some rock outcrops. The operator has developed processing areas in flatter places adjacent to the quarries (Photo 1). The processing areas are excavated about one to two feet compared to surrounding areas.

Photo 1. North quarry and processing area. Area proposed for future quarrying is in the foreground on the extreme right of this photo.

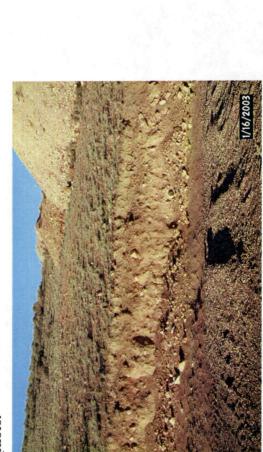
There is at least four to six inches of actual topsoil available in the processing areas with additional subsoil that could be salvaged as well (Photo 2). Although there are some soil stockpiles around the processing areas, it does not appear the operator has been salvaging all available topsoil. In addition to the topsoil, there is subsoil that could be salvaged to make up for potential deficits in the quarry areas.

Photo 2. Edge of the north processing area. One can see three soil horizons in this photo. In the upper right are what appear to be two soil stockpiles.

Our primary concern is with the amount of soil that has been salvaged from the processing areas. Any expansion of these areas should definitely include a soil survey to determine how much soil to save. Some information about the material on the floor of the pads would also be useful since this material will probably be needed as a subsoil in reclamation.

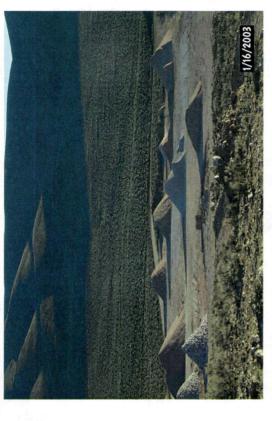
Photo 3. South processing area.

The only equipment on site was a front end loader. I was very impressed with how cleanly the operation is being run. We saw no trash or scrap equipment, and even the material stockpiles are neat (Photo 3).

The operator has proposed a soil borrow area south and west of the south processing area shown in Photo 3. This borrow area is a little lower than the processing area, and I expect it would have deeper and more developed soils.
